Bald Eagle *Haliaeetus leucocephalus* Electrocutions in Alaska and Florida - a comparison of retrofitting measures

Richard E. Harness

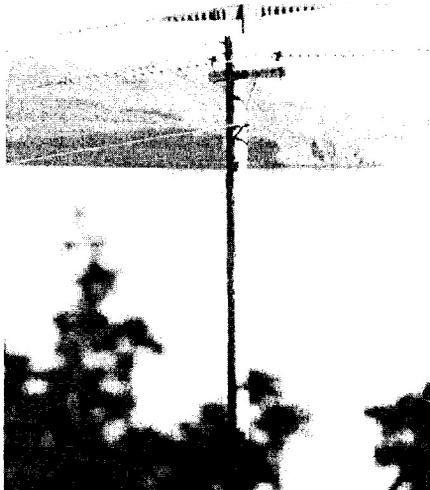
Alaska retrofitting primarily includes perch management and the insulation of exposed jumpers and installing bushing covers on equipment. Conductor guards (Figure 2) were specified in areas where birds concentrate, as these devices allow birds to safely perch on crossarms.

Figure 2. Pole raptor protected with a conductor guard

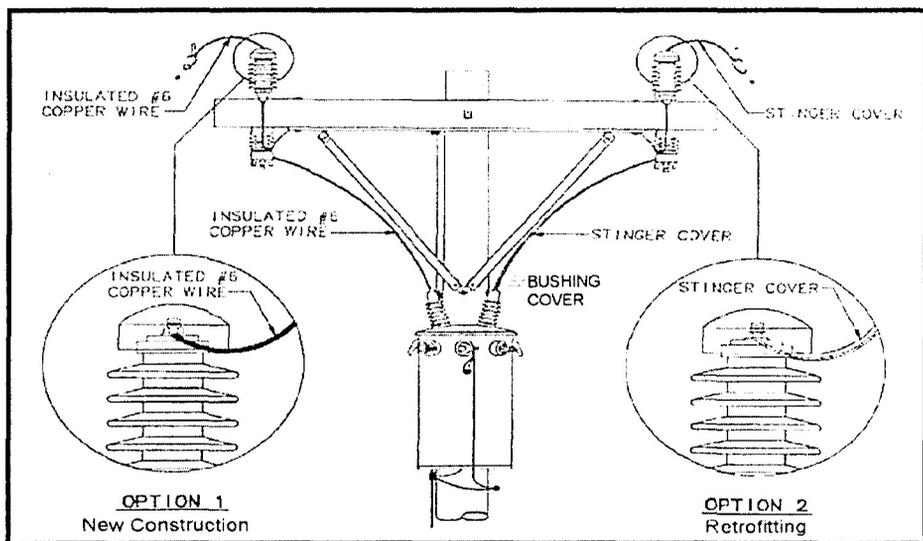
Unlike Alaska, Florida retrofitting requires a particular focus on covering exposed lightning arresters and associated jumpers. Because Florida

experiences the highest lightning levels in the United States, Florida utilities typically place lightning arresters on every third pole and on all equipment. Arresters clear over-voltage problems such as lightning strikes. Arresters have a groundwire attached to one end leading to earth and another end either attached or in proximity (gapped) to an energized wire (Figure 3). The spacing of these arresters can be problematic for both medium and large birds. For this reason, all arresters should be installed with manufacturer-supplied wildlife caps. 600v rated insulated covering also should be used for all arrester hot leads. No exposed wire should extend beyond the wildlife cap, and leads should be kept as short as possible. Most poles near the Florida coastline also have bonded hardware due to salt contamination issues. Bonded hardware in proximity to energized wires can be problematic for large perching birds.

Figure 3. Installing new and retrofitting surge arresters
