# Vulture Electrocutions on Vertically Configured medium voltage Structures in the Northern Cape Province South Africa

Rudi Kruger, Abri Maritz and Chris van Rooyen

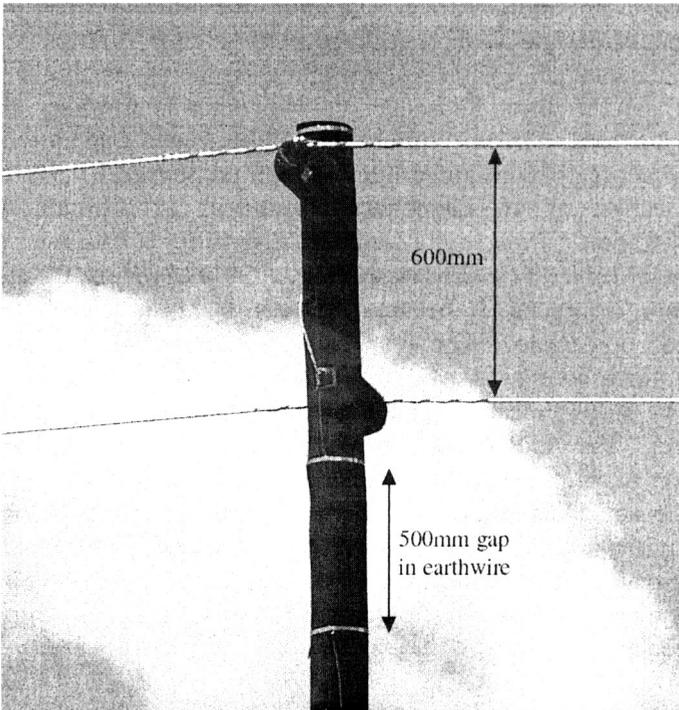
**Figure 1: 22kV single phase, vertically configured design**

Initially, investigations concluded that the most likely cause of death of the vultures was phase to phase electrocution. The reason why specifically vultures were being electrocuted was thought to be related to:

It was thought that electrocution takes place when a vulture attempts to land on the pole top and loses its grip due to the small size of the top, or when displacement takes place and the interaction causes the vulture to slip between the conductors.

- Vertically configured medium voltage designs hold an inherent risk of electrocution for large gregarious scavenging vultures.
- Vultures found 5-10 metres away from the pole could have been electrocuted while perching on the bottom conductor and simultaneously touching the top conductor (the distance between conductors is less than the perching height of all three species electrocuted).
- Electrocutions could have occurred at poles due to interaction between vultures, causing a vulture to bridge the gap between phases.
- The method of insulating the conductors adjacent to the insulators is not sufficient to prevent vulture electrocutions.

After the first round of investigations in 2000, the investigation team recommended that the top conductor should immediately be insulated with Salisbury sleeves or Preformed Line Products (PLP) sleeves one metre either side of the insulator at all four electrocution sites to prevent further phase to phase electrocutions.

- The current method of insulating conductors with Salisbury sleeves or Preformed Line Products (PLP) sleeves one metre either side of the insulator must be discontinued
- Areas must be identified within the Northern Cape where vultures are most exposed to the risk of electrocution
- All vulture-unfriendly lines in the high risk areas must be identified
- A programme of line modification must be undertaken in the high risk areas to prevent further vulture electrocutions
- The use of vertically configured medium voltage structures for new lines must be discontinued in areas where vultures regularly occur in the Northern Cape
